PALATAL OBTURATOR PROSTHESIS: A CLINICAL CASE REPORT

Husniyati ROSLAN, Sa'adiah SHAHABUDIN

This case report demonstrates the combination of Polymethyl methacrylate (PMMA) with soft heat curing acrylic resin to construct an obturator in a patient with mucoepidermoid carcinoma.

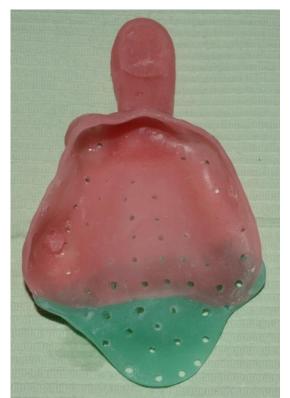
Impressions were poured using type IV dental stone (William Dental Hard Stone, Malaysia). A special tray was then fabricated using coldcure acrylic resin (Megadenta, Germany) (Figure 3). Secondary impression was taken using monophase polyether impression material (3MTM ESPETM, Germany).

Figure 3. The special tray constructed for the secondary impression.

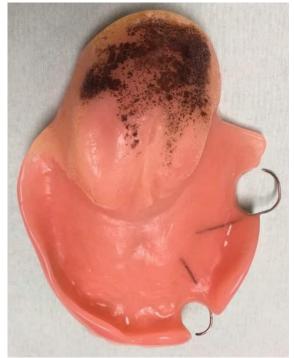
However, upon the follow-up appointment at 9 months, we could see some black stains on the fitting surface where the indirect soft acrylic resin was placed (Figure 9).

Figure 9. Some black stain present where the soft acrylic resin was placed on the obturator.

The mucosa at the defect areas appeared normal. Therefore, swabs were taken from the black area on the obturator and the related mucosa intraorally. The black stain on the obturator was gently removed using fine polishing bur. The swabs were sent for a culture and sensitivity test to find microorganisms that caused the staining. The result confirmed that there were no microorganisms at both areas. The patient was told about the laboratory result and was advised to use a denture cleanser. The stain will be further review in three months to monitor the condition.

the fitting surface. With the current obturator, some black staining was present on the fitting surface where the soft heat curing acrylic resin was placed. Even though the patient practised good oral hygiene, the black stain still appears. We hope that with the use of denture cleanser, it will help to remove the stain from the obturator.
